## ACCIDENT WITH TIMBER COLONNADE OF THE 200 YEARS OLD CHURCH AND METHODS FOR THE STRENGTHENING

**Abstract:** *The article describes an accident in colonnade of the 200 years old church, "Sv. Uspenie Bogorodichno" in Kyustendil. The article has investigated several interesting approaches to amplify damaged wooden columns in historical structures in China, Azarbaijan, Iran, Spain and USA. The decision was made to temporarily reinforce the whole structure of the church during its renovation and the method of strengthening the damaged wooden columns in the church was propose.*

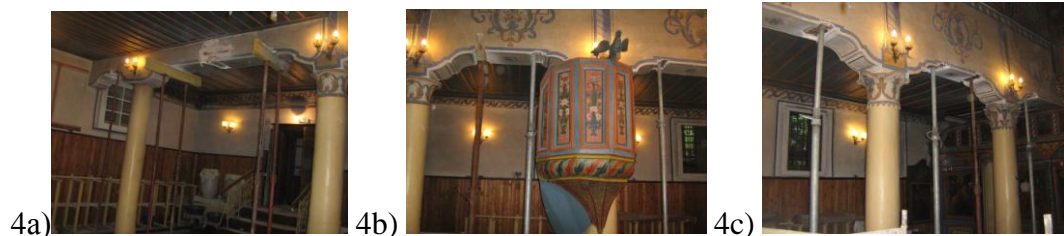
columns taking the loads from the roof structure on 15.06.2015 is severely cracked during the night, which indicates a degraded load bearing capacity which imposes their emergency reinforcement with a metallic scaffold mounted between the columns (Fig. a, b). On the day of 16 June 2015, a partial temporary reinforcement of the church's support structure was carried out, covering certain areas under the longitudinal wooden beams above the wooden columns, with metal stands from the Ninebeck scaffold (Figures 4a, b, c).

**Fig. 4a, b, c.** Replacing in certain places the longitudinal wooden beams located above the wooden columns with metal stands from the Huenebeck scaffolding on the A axis.

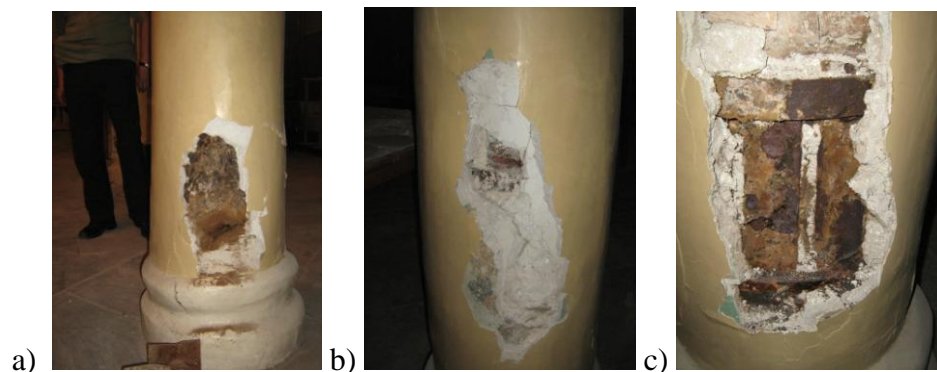
The observation carried out on the damaged and cracked cover on the columns and its detection in several places made it possible to describe the following facts. The wooden columns have a circular cross-section with a diameter of 46cm. Their support is done on stone base that protrude above the floor of marble slabs at a height of about 50cm. The revealed wooden columns show an interesting composite wooden-steel structure, made of timber, on which steel rings are attached (Fig.5a, b, c).

**Fig. 5a, b, c.** Cracked outer cover of the column in the church shot at 16.06.2015 at 18.30 hours. The ties are arranged side by side, on which about 40 cm are placed steel rings with a height of 40 mm and a thickness of 2.0 mm. The rings are attached to the wooden column with ordinary iron nails

The proposal for a design-construction solution for the rehabilitation of wooden columns in the naos of the church "Sv. Uspenie Bogorodicno", taking into account the high pressures in them, the disturbance of the wood structure at the lower end and the unfavorable humidity and temperature conditions for many years of work will be done in several options according to the above mentioned examples. For our cases, however, the most commonly applied solutions are the dentures of columns with wooden dentures which reach 1-2 m height.

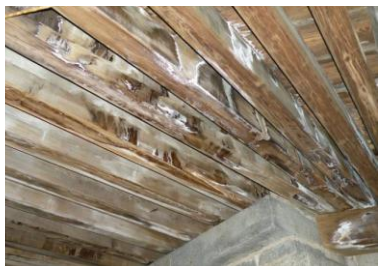
high moisture contents within the masonry and the wood (Fig.17). Moisture contents were typically greater than 30 percent, indicating that the wood has a favorable moisture environment for active wood decay. However, the fort's close proximity to the Atlantic Ocean and the presence of efflorescence on the masonry and wood, as well as the presence of "fuzzy" wood (Fig. 18), indicates the presence of salt in the wood, which can dramatically influence moisture content readings taken with an electronic meter. Archival research has also revealed that the engineers at Fort Adams were negotiating with the holders of the U.S. rights to John Kyan's process of treating timber against decay with a "corrosive sublimate" material that likely contained mercury salts, which, if used, would also have an influence on the moisture content readings. Additional testing of material samples, such as chemical analyses and oven-drying samples to attain true moisture content readings will be required to confirm whether the timbers were treated and what effect the treatment had and may continue to have on the performance of the timbers.

17)  
**Fig. 17 and 18.** Moisture stains, efflorescence on joists within a corner casemate and arch;

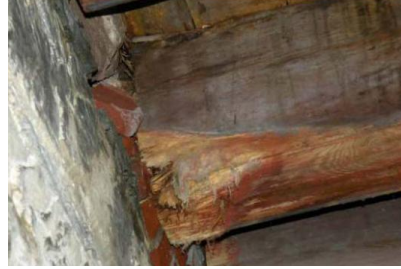
18)  
**Fig. 18.** Fuzzy (PUH, MAH, ZACAPAN, NEYASEN) wood on a timber joist along the west wall

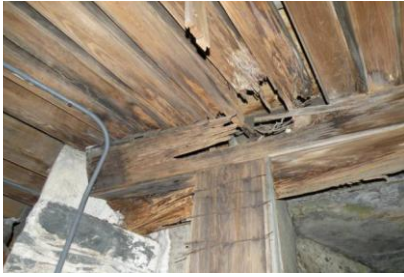
Fig. 19: Deteriorated girder and joists within a casemate.

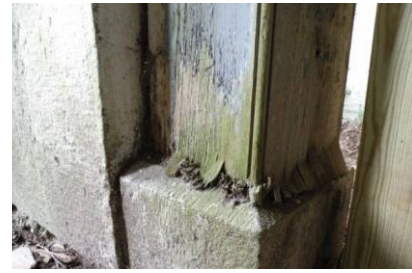
Visual inspection, used in combination with probing the wood with an awl, allows for the rapid identification of missing or broken elements as well as voids, incipient decay, and advanced decay present near the surface of the wood. For the quantification of internal deterioration, resistance drilling must be used. Resistance drilling, a quasi-nondestructive technique, is used to identify and quantify internal voids and decay by determining the relative density profile of the wood. At the fort, a combination of visual inspection, probing, and resistance drilling was used to identify and quantify deterioration in the structural timbers. Wood conditions found within the fort were divided into three classifications: good, fair, and poor. Good condition describes wood that may exhibit moisture staining and/or efflorescence but is not structurally impacted and has no evidence of insect damage or deterioration from wood decay fungi. Wood in fair condition may have minor insect damage and may also exhibit evidence of past moisture damage, including minor deterioration from wood decay fungi. Wood in poor condition may have severe visible insect damage and may also exhibit ongoing deterioration caused by wood decay fungi. In general, most of the structural members within the fort were found to be in fair to good condition along their lengths; areas of poor condition tend to be limited to the bearing areas. In a few instances, the structural members are in extremely poor condition and have failed due to deterioration caused by wood decay fungi (Fig. 19). Some of the posts are "brooming" at the base due to a combination of high moisture content and deterioration by wood decay fungi (Fig. 20).

Figure 20: Brooming at the base of a column.

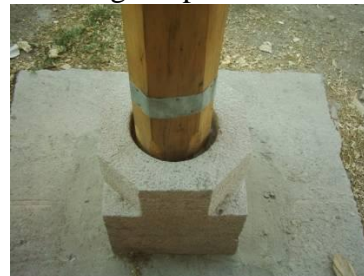
As concern the pathology of wooden structures in mehrabad mosque in Bonab, we can say that the main element of damage on the body and decoration of Mehrabad mosque is decay of the materials, overloading and humidity in the inner spaces. Overloading, decay of the materials and the foundation because the columns lose their stability, bend, and the stone bases are moved. To solve the problem, piling the columns, replacing the stone bases, and enforcing the foundation was carried out(Fig.24a,24b). Then the columns and the stone bases are returned to their former position. The other problems include the breakages in wooden parts of the column caps, and the boxes because of the pressure inserted through metal joints (nails) and lack of resistant against the inserted pressures. In this stage, by using the piling and raising the main beams, the caps are separated from their original place; so, some of them are repaired and some are renewed. The loose parts are restored and the metal joints are fixed. In the parts that wooden parts were decayed, these parts are changed and the caps are restored on their original place.

**Fig. 24b:** Restored foundation and stone base
