**CHURCH OF SAINT THEODORE,
BOBOSHEVO, PROVINCE OF KYUSTENDIL
A survey and project for conservation and restoration**

Architecture: Arch. Hristo Ganchev¹, Arch. Yuliy Farkov², Arch. Vladislav Kolarov³
Structure: Anton Maleev, engineer
Frescoes: Iliya Nikolov, Nina Nikolova

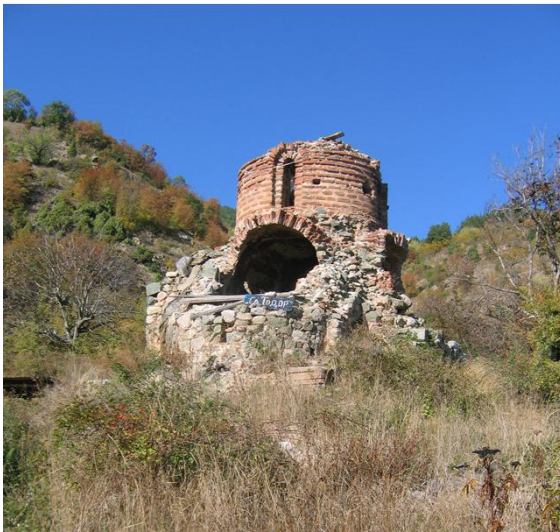
Fig.1.

The Church of Saint Theodore is located 2 km north of the town of Boboshevo. The archetype and some particularities in the construction technology (which will be described later) provide the grounds for the authors to presume that the church was built during the period of the second flowering of Byzantine architecture (867-1204 CE) – more precisely, during the eleventh century. A particular characteristic of Byzantine architecture is the decorative richness and sculptural expressiveness in a unified architectural design that combines and is subservient to an organic link between arches, vaults, and domes. The so-called tectonics (the harmonious unification of structural form, function and systematics with artistic and aesthetic symbolism and significance) of the buildings is additionally accented by the decorative impact of the materials used in the different elements, so that in this way an integrated whole is achieved in the artistic impact (fig. 1).

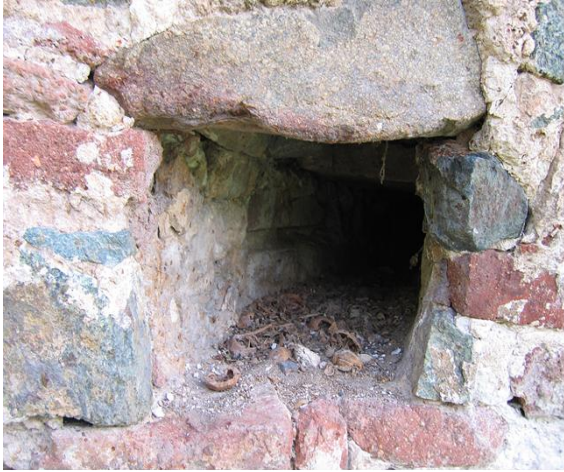
Fig.4

damp in the walls. That is why these openings could have helped to ventilate the building and quickly remove the damp (fig. 4).

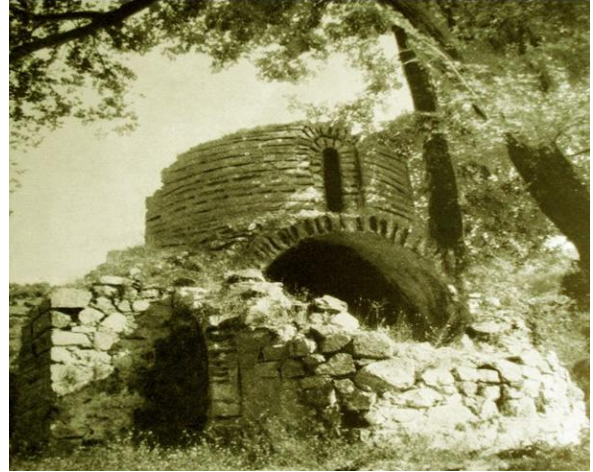
Fig.5

We garnered information regarding the preserved original structures of this cultural monument from preserved archival photographs from the end of the nineteenth century and the beginning of the twentieth century (fig. 5). As regards the interventions carried out and the preserved parts of the building, as well as the availability of authentic data, we made our judgements from the survey carried out on-site regarding:

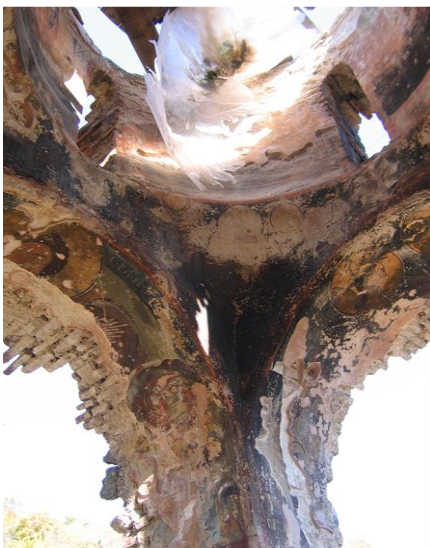
Fig.8.

Technical condition: the stability of the building is generally ruined as a result of serious destruction and compromised or weakened connections between the load-bearing elements; the stability of the structures themselves is in a critical state due to ruin and weakening of the strength of the mortar; the grouting of the facades has lost its structure everywhere; poorly implemented patching and reinforcement with unsuitable sealings; erratic earthworks (fig. 8).

The first conservation works on the polychromatic decoration and paintings of the church were carried out in the 1970s. The preserved fragments from this stage amount to about 57 square metres. Despite a series of interventions carried out over the years and administrative correspondence in the period 1993-2010, the “temporary wooden sheathing” collapsed onto the church. The frescoes and plaster support subsequently experienced exceptionally aggressive stress. (fig. 8 and fig. 11)
