## ACCIDENT WITH TIMBER COLONNADE OF THE 200 YEARS OLD CHURCH AND METHODS FOR THE STRENGTHENING

**Abstract:** *The article describes an accident in colonnade of the 200 years old church, "Sv. Uspenie Bogorodichno" in Kyustendil. The article has investigated several interesting approaches to amplify damaged wooden columns in historical structures in China, Azarbaijan, Iran, Spain and USA. The decision was made to temporarily reinforce the whole structure of the church during its renovation and the method of strengthening the damaged wooden columns in the church was propose.*

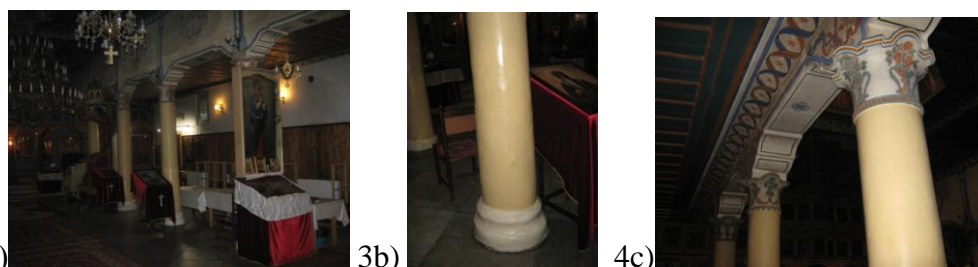
**Fig. 3a, b, c.** View on the inside of the church and in particular on the lower and upper end of the wooden columns

At the top, the columns before being connected to the vaults are decorated with special ornaments, which are in good condition (fig.3c). The coating of a part of the wooden

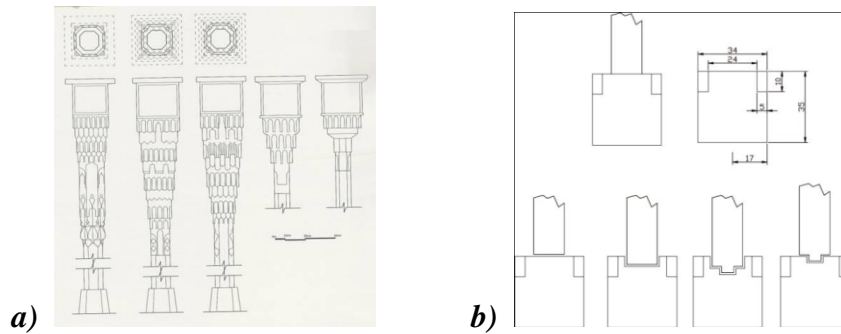
**Fig. 22a,b.** a) Capitals of Mehr- abad Mosque- Bonab; b) The method of arranging pillars on stone

The column bases are all made of stone and in different mosques have different forms and thickness (Fig. 22b). The form and shape of the column bases are circle, square, and hexagon, but the bases are generally square on the floor and the upper part is hexagon. The material of the mentioned column bases is all black and white sedimentary stones or engraved marbles. The bases have been located on foundations that their dimension is about 1.5\*1.5 m and the estimated depth is 80-90 cm. Connection of the stone bases to the foundation: flat; mortise and tenon. The column is directly located on the stone and there is no connection or mortar between the bases. The load which is transferred from the column to the base keeps the column body firm on the base. The end part of the column body is located on the mortise of the stone base which is different in the mosques. This connection is called mortise and tenon. In this connection like the flat one, there is no connection and mortar; however, in rare cases there is a space between the connections which mostly has been considered for expansion and contraction. The last part could be located inside a special pad. As the height of the column increases, its volume increases too. In high caps, this combination or increasing the volume of the caps from down to the top is influential in dividing the load. The diversity in columns and column caps in addition to showing the ability of the carpenters, could create diversity and movement in the space. Generally the caps of the columns in the mosques are divided to five groups according to their stalactite works. The column caps with rectangle section or square with decorative arches are decorated in the form of a horn of the goat. Column caps with rectangular or square section with sharp arches such as Mehrabad and Kabood mosques in Bonab. Caps which have changed from rectangle to circle. As mentioned, most of the columns are lead to the cubic wooden box where the pad) of the column cap is located on it.

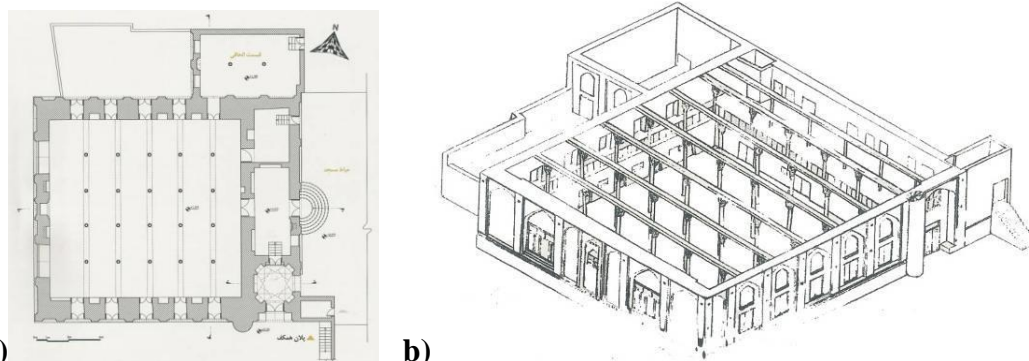
**Fig. 23a,b.** Ground floor plan Mehr- abad mosque; Perspective section Mehr- abad mosque - wooden structure
